Inspection Report

Mine Name: Lisbon Valley
Operator Name: SUMMO USA

Permit number: M/037/088
Inspection Date: May 19, 2005
Time: about 8:30 to 10:45 AM

M/037/088, Lisbon Valley Mine, SUMMO USA, Inc.

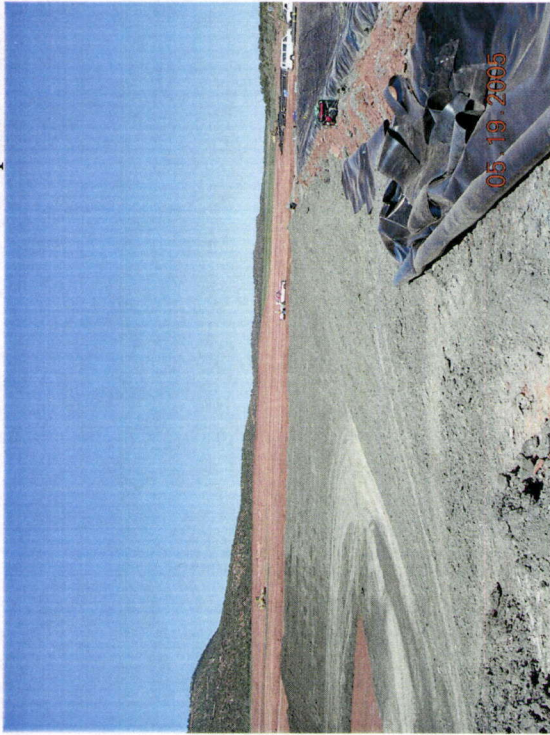
Photos 1 and 2 show two stages of liner installation in the ponds. In Photo 1, the clay liner is being installed. This clay was being mined from an area adjacent to the Centennial Pit (Photo 3). Photo 2 shows the HDPE liner with geotextile being installed.

Photo 1. The clay liner being installed on the slopes of the raffinate pond.

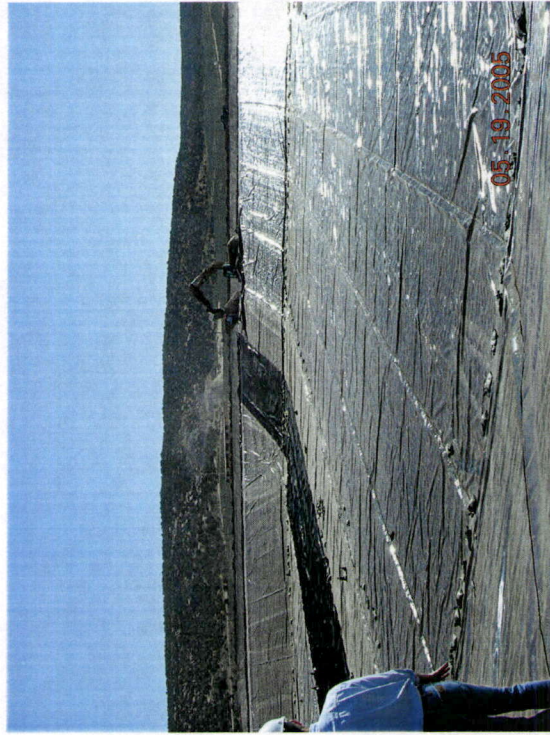
At the time of our visit the operator was lowering the elevations of the pond overflows, it seems that at the initial elevation, solutions in the ponds would cover the leach pad leak detection pipes. The Department of Environmental Quality requires that these pipes always be exposed to allow the operator to monitor for leaks in the heap liner.

Photo 2. Secondary HDPE liner and geotextile being installed in the pregnant solution pond. Trackhoe working to lower pond overflow cut in the background.

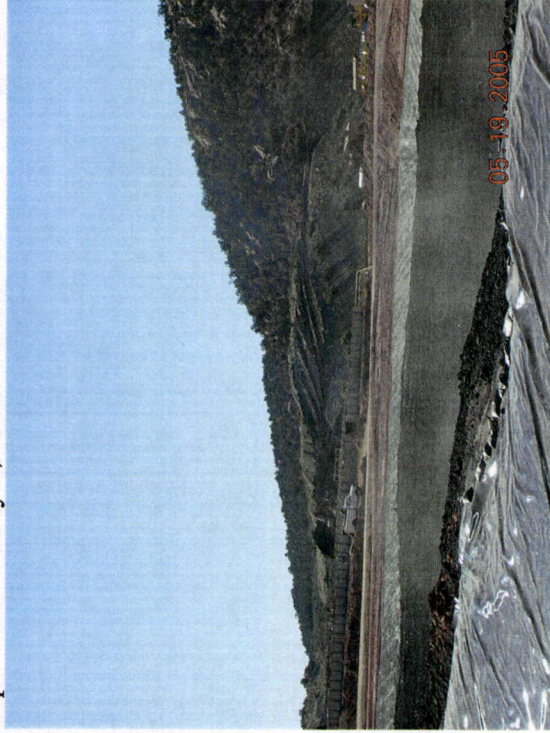
Photo 3. The area from which clay is being taken is in the dusty background near the center of this photo.

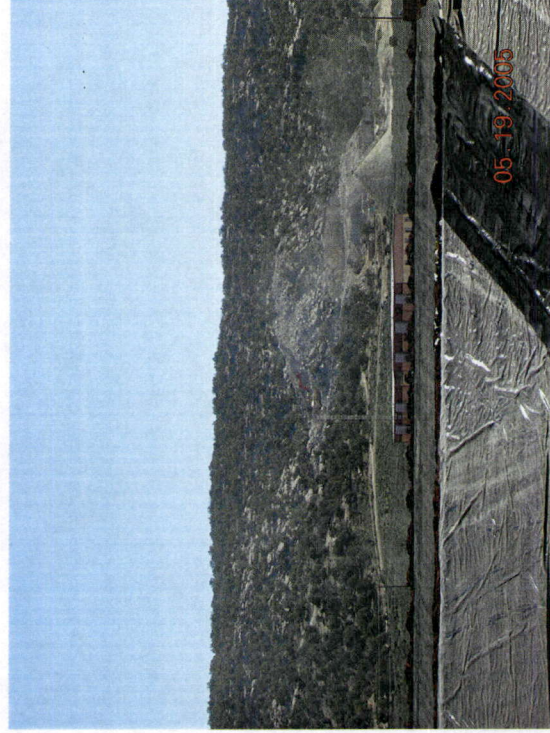
The material to be placed at the base of the heap leach piles and over the HPDE liner was being mined from one of the Sentinel Pits, I believe Sentinel #2. The stockpile of this material is shown in the center-right background of Photo 4. This material will serve as a drain base for ore that will be placed on the heaps.

Photo 4. The overliner (or underliner) material stockpile is in the background in the center right of this photo.

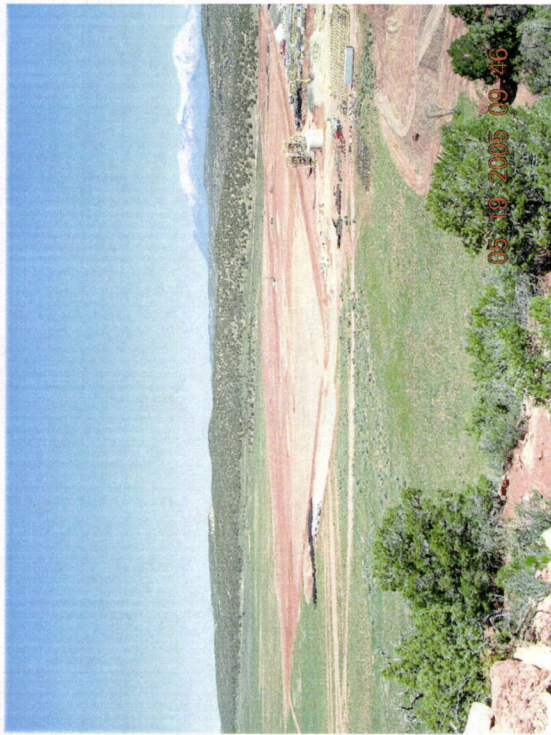
Photo 5. Overview of the heap leach pad.

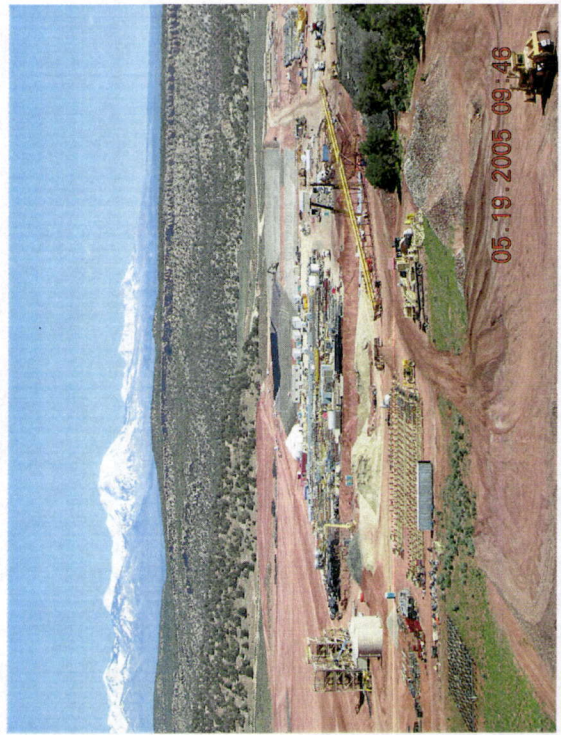
Photo 6. Overview of the facilities area, solution ponds in the background.
